Solar panel installation in Kisenyi

An alternative energy supply to the existing water treatment project

By Valentin J. Koestler & Marius Koestler
Fontes Foundation, www.fontes.no
October 2009

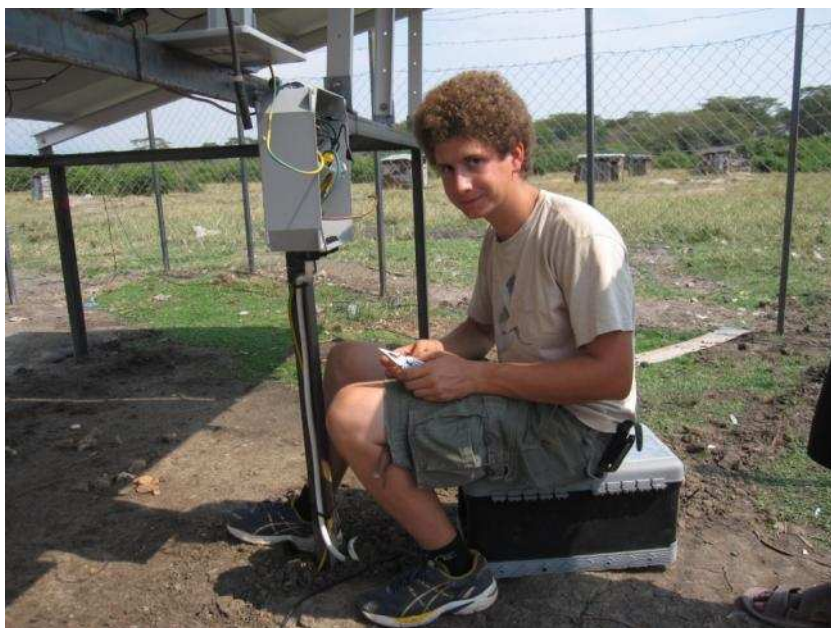
Valentin Koestler having been responsible for the installation of the solar system is doing electrical connections in the control box for the solar panels.

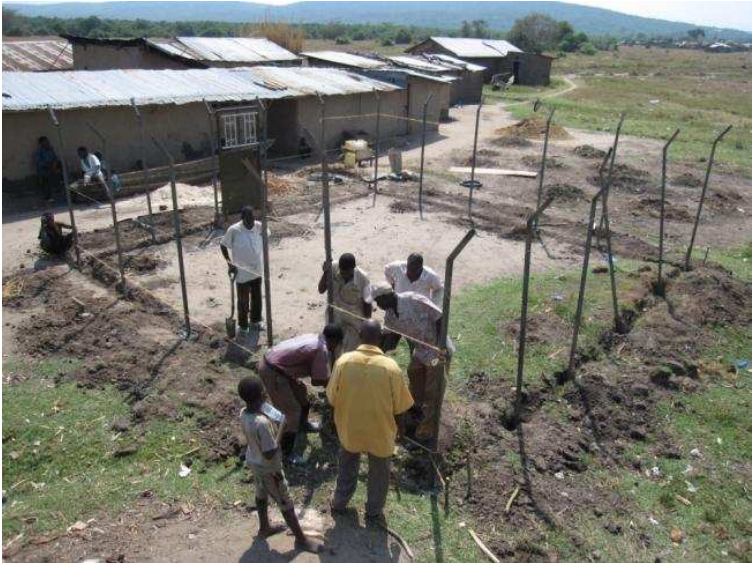
A fence covering 7 by 7 meters was put up in order to protect the solar panels from both people and wildlife. The poles were dug approximately 40cm into the ground and anchored with concrete. First a 6 feet tall wired netting was put up, and then three rounds with barbed wire on the top.

The fenced compound for the solar panels being constructed.

Some poles have already been broken because a hippopotamus scratching its back against it. Sharp rocks will be put up around the fence so that hippos will not destroy it again, because hippos don't like walking on hard and sharp ground.

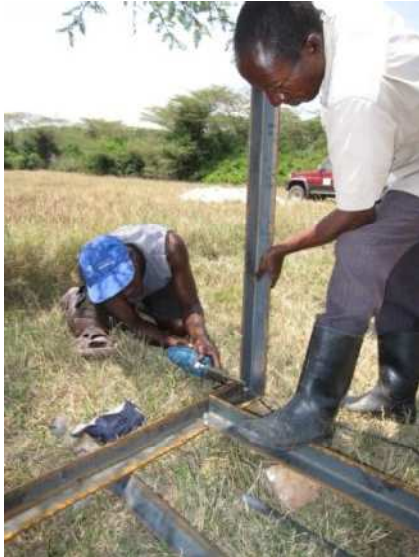
As a foundation for the solar panels it was chosen to use steel angle irons of 60x60x6mm. Because this was faster too assemble, such a construction was used instead of a concrete foundation. In earlier constructions making accurate structures with good strength concrete basis have also proved to be difficult. It was chosen to bolt the angle irons together instead of welding as there was neither a welding machine nor the required skill nearby.

Drilling of holes in the angle irons.

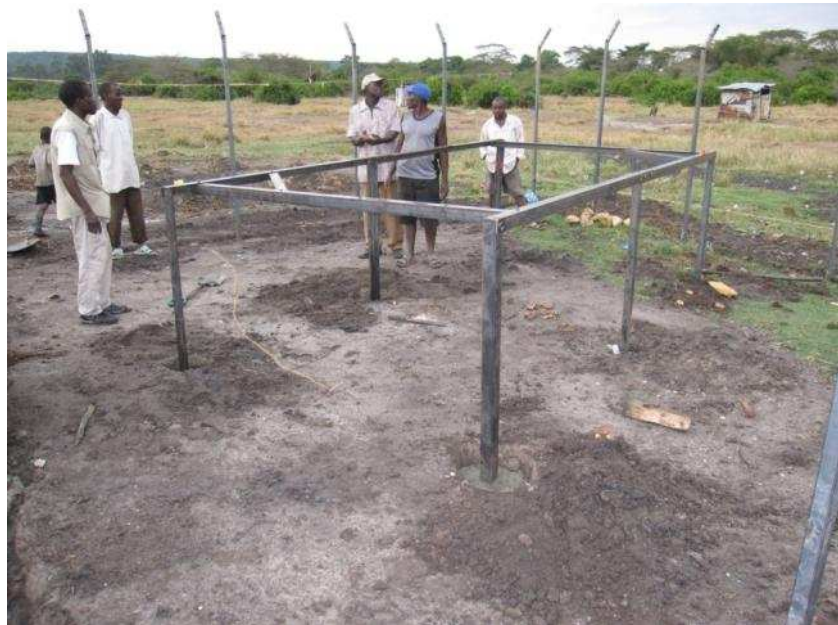
The angle iron was bolted together into a rectangular frame with six legs, 400cm long, 210cm wide and 150cm long legs. Each joint had two bolts. Due to transport limitation the long sides of the rectangle were joined from two pieces. The legs were dug about 50cm into the ground and concrete was poured around them. To add traction between the legs and the concrete, slits were cut into the legs and binding wire was put around. Concrete has also to protect the legs from rusting.

The frame being aligned within the compound and concrete was poured around the legs.

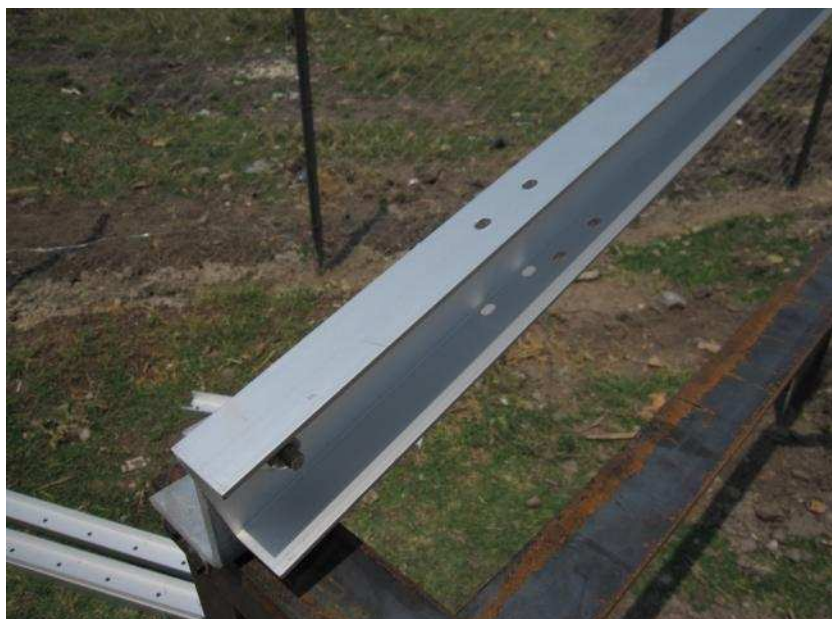
The installation of the support structure was straight forward, except that the main girders have two sets of holes for solar panels with a slightly different spacing: on one side the spacing is 60cm and on the other 62,3cm. This was not mentioned in the documentation of the support structure and was at first not noticed.

The slightly offset holes in the support girders.

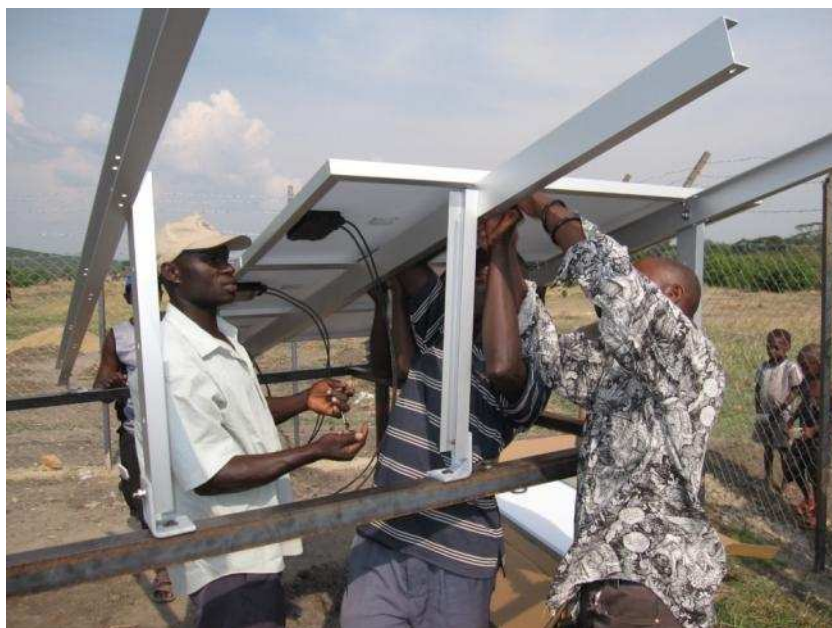
The solar panels were easily mounted to the support structures with four bolts for each panel.

Installation of solar panels

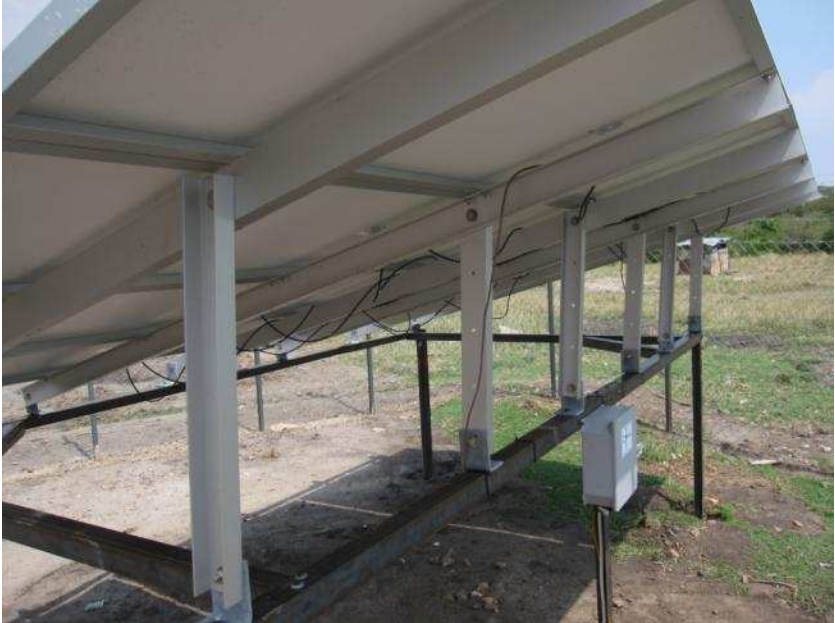
The solar panels from below. The panel control was bolted to the metal frame.

The panel control was fixed to the metal frame with three bolts. When doing this it was noticed that the bolts holding the rectifier diodes used to separate different solar circuits (not in use in this installation) in place are extending slightly from the back plate of the panel control which makes it difficult to bolt it onto a flat surface. The earth, panels and the cable to the pumps were connected to it.

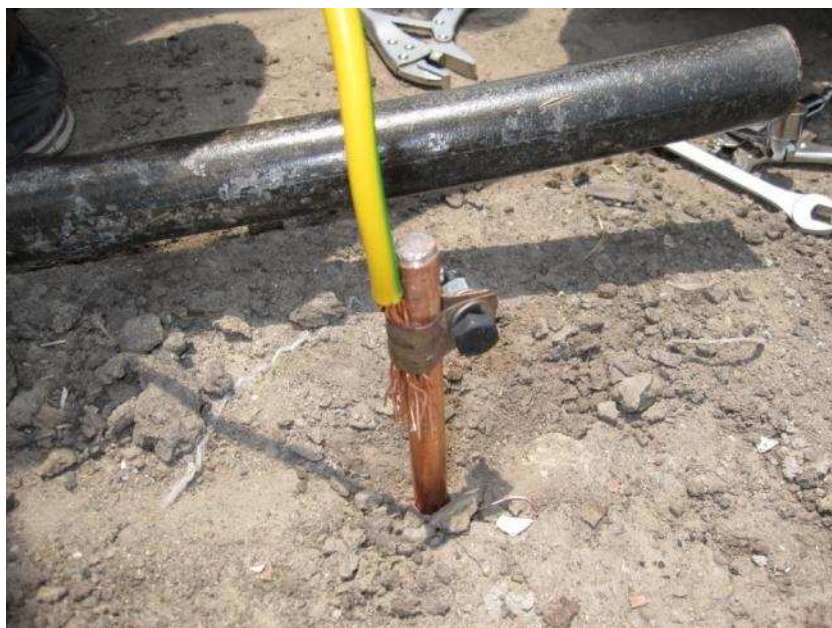
A six feet copper covered steel earth rod was supplied. The rod was forced into the ground just besides the panel control. There was no clamp supplied to attach the earth wire to the rod, so a clamp was made locally. Since the soils are wet a resistance of less than 1 Ohm was measured between the support structure of the panels and the earth rod.

The earth rod with an improvised clamp, it was forced into the ground so that it is no longer visible.

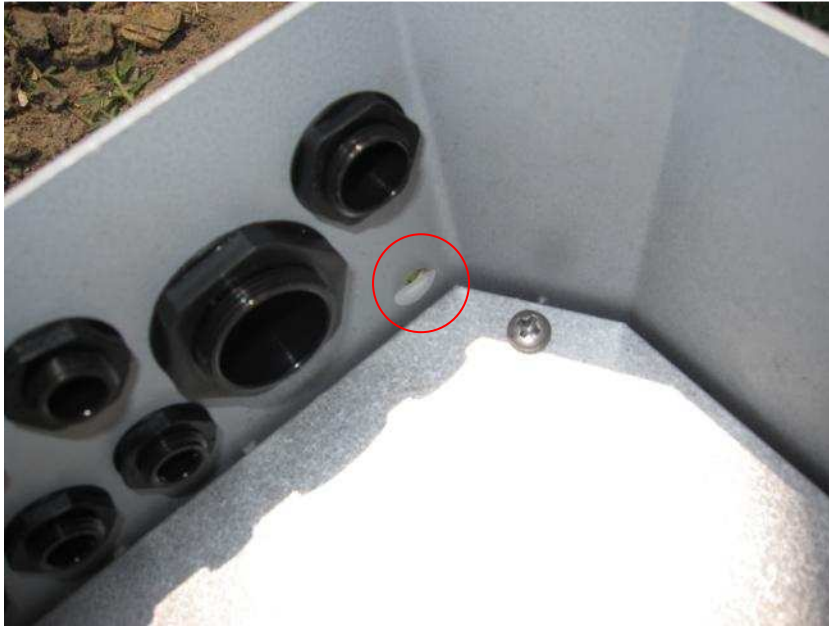
The small uncovered hole in the panel control. In tropical areas it is highly important to avoid any small animals to enter electrical installations.

The panel control box had a hole which was only covered by a sticker which had already fallen off. This hole was sealed with silicon. Because the main cable used was too thin for the biggest cable bushing, ants had made their way inside the box. Therefore all the holes and cable bushings were sealed with silicon.

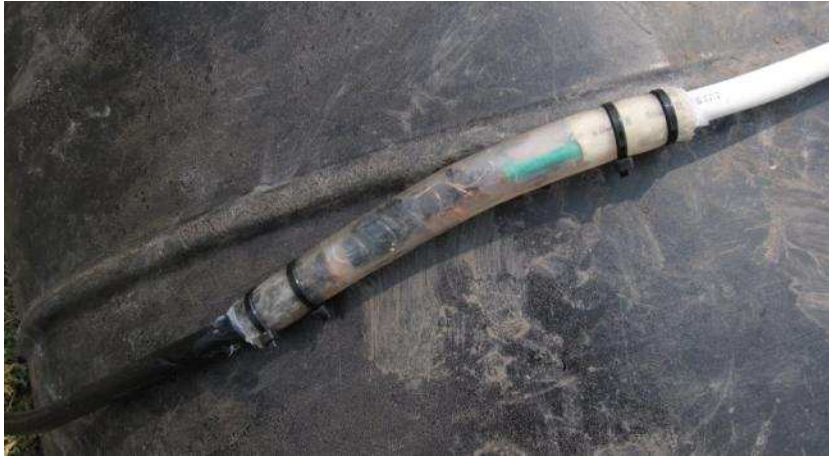
None of the cable joints was part of the kit, so the connections were made by soldering the leads together, insulating with heat-shrinkable tubing and then a small piece of hose was pulled over the connections for protection. The joint was then filled with silicon to make it waterproof.

One of the cable joints on the main power cable.

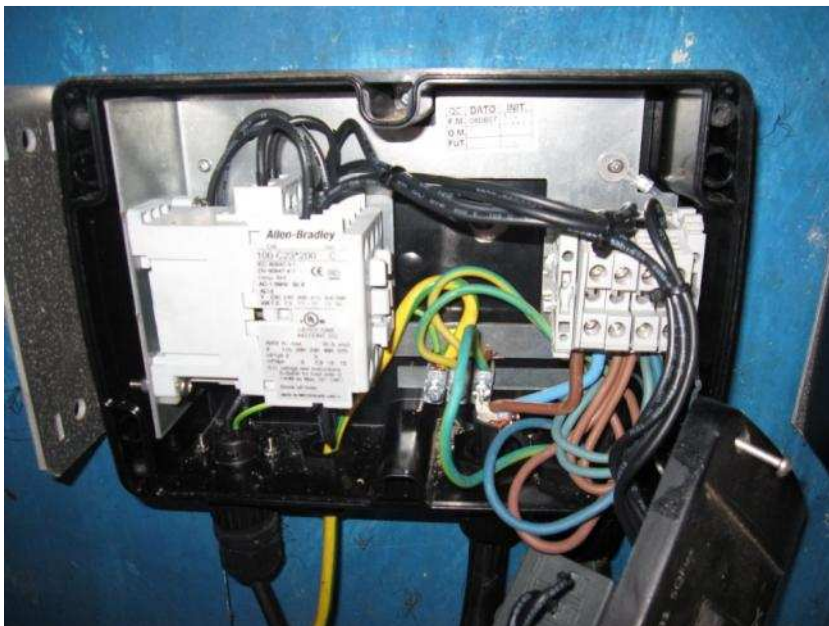
The Grundfos IO101 switch box is located in the control and pump house. It has a built-in relay which automatically switches to generator power when it is turned on. This is practical in cases when there is not sufficient sunshine. In addition the box has a main switch.

Inside the Grundfos IO101 after the connections were in place. The white box on the left is the relay for automatic switching between solar and generator power.

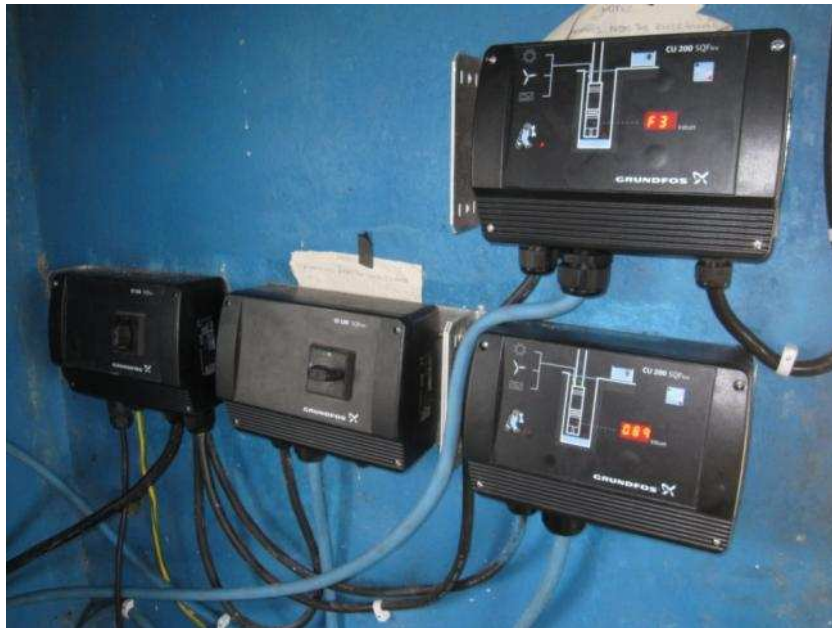
For the pump in the settlement tank the CU200 worked very well, but the CU200 failed to communicate with the pump at the river intake (F3 error). It states in the manual that the communication only works with cables up to 200m, but the cable in use is only 80m. Still the controller works as an on/off switch and for the level switch.

The control boxes while operating. The panels are currently producing 0.89 kW.

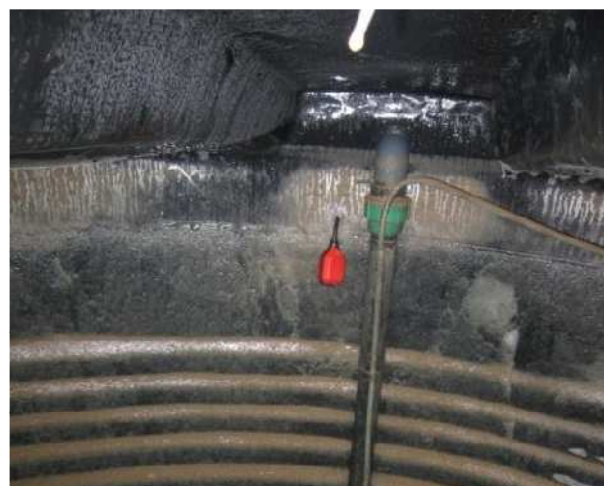
The switch was mounted by drilling an 8mm hole into the settlement tank (PE), a little below the level when it is full, and the cable was pulled through this hole from the inside. Afterwards the cable was extended and connected to the CU200 pump controller.

The level switch (red) mounted inside the settlement tank.
